Inspection Report

Property Address:
46 Sunflower Ln
Fletcher, NC

Tru-Chek Home Inspections

| Date: 9/26/2007 | Time: 5:36 PM | Report ID: 07-8-101 |

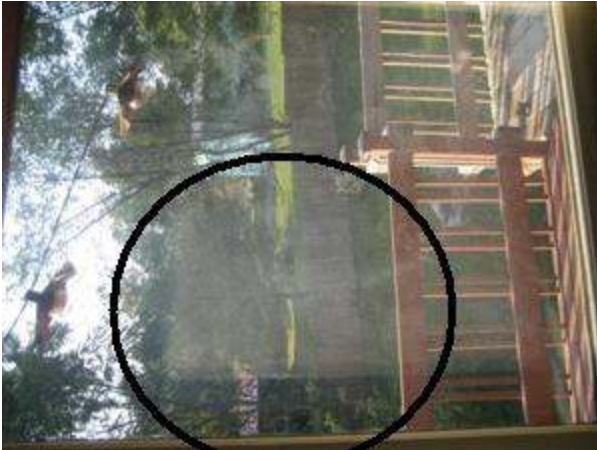
2.2 Picture 1

2.2 The glazing between glass panes are failing at most windows.

The glazing between glass panes are failing at most windows.

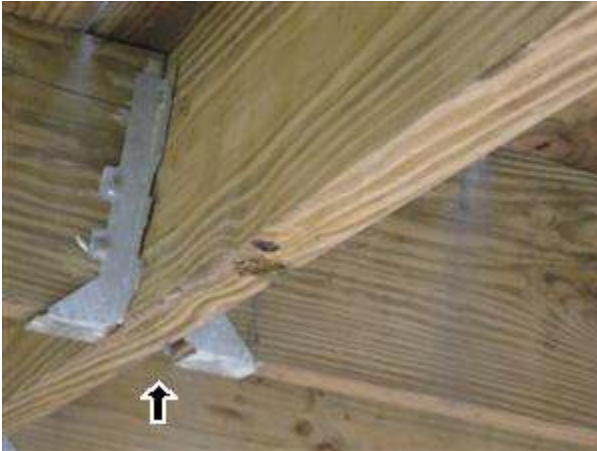
2.3 Picture 1

2.3 The girder that supports joists on the deck at the rear of home improperly supported. A repair or replacement is needed. A qualified contractor should repair or replace as needed.

The girder that supports joists on the deck at the rear of home improperly supported. A repair or replacement is needed. A qualified contractor should repair or replace as needed.

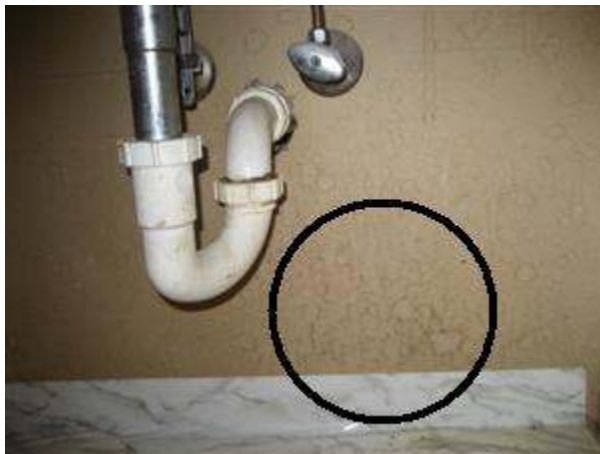
6.1 Picture 1

6.1 The sink faucet leaks at the master bath. Repairs are needed to stop leaking water from damaging the cabinet bottom[Previous signs of water inside cabinet] or to eliminate moisture that may contribute to fungi growth. A qualified person should repair as necessary.
